November 2000

MAINTENANCE BULLETIN

Alfa Company

Certain Compactors May Overheat in High Ambient Temperature Conditions

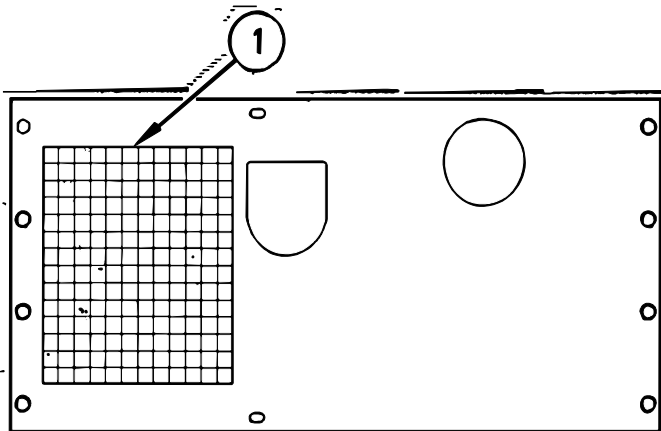
Illustration 1

(1) Vent holes in top panel

If the vent holes are not present in the top panel, replace the panel with 180 - 5304 Top Panel.
